Cutting unbonded post-tensioned slab

Unbonded post-tensioned slab

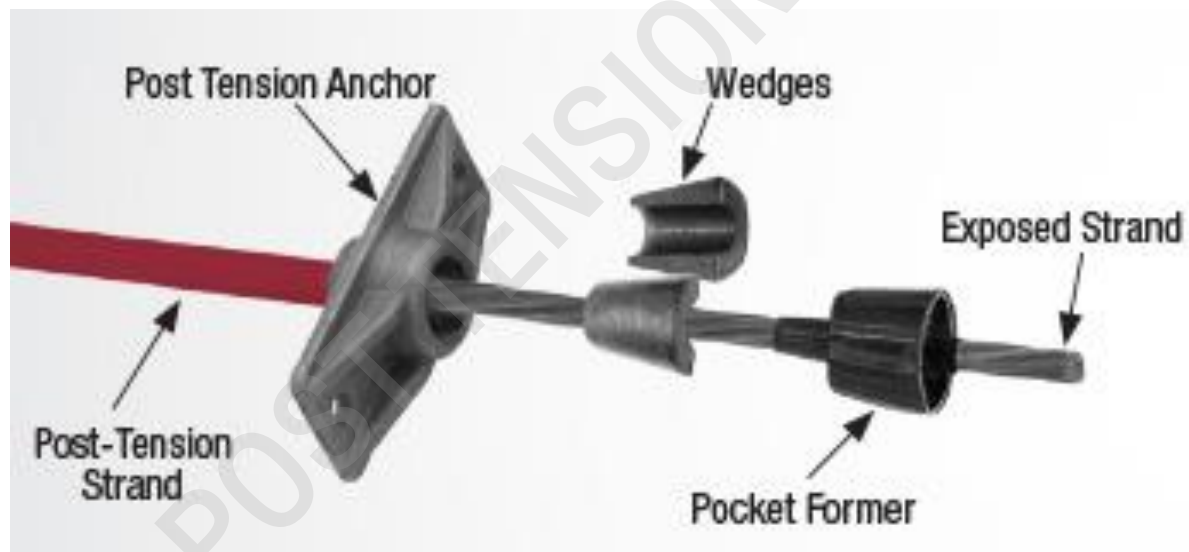
This system is not currently used but some more than 30 years buildings use this system. This system consist of one strand in one tendon and strand was coated by grease in PE sheath.

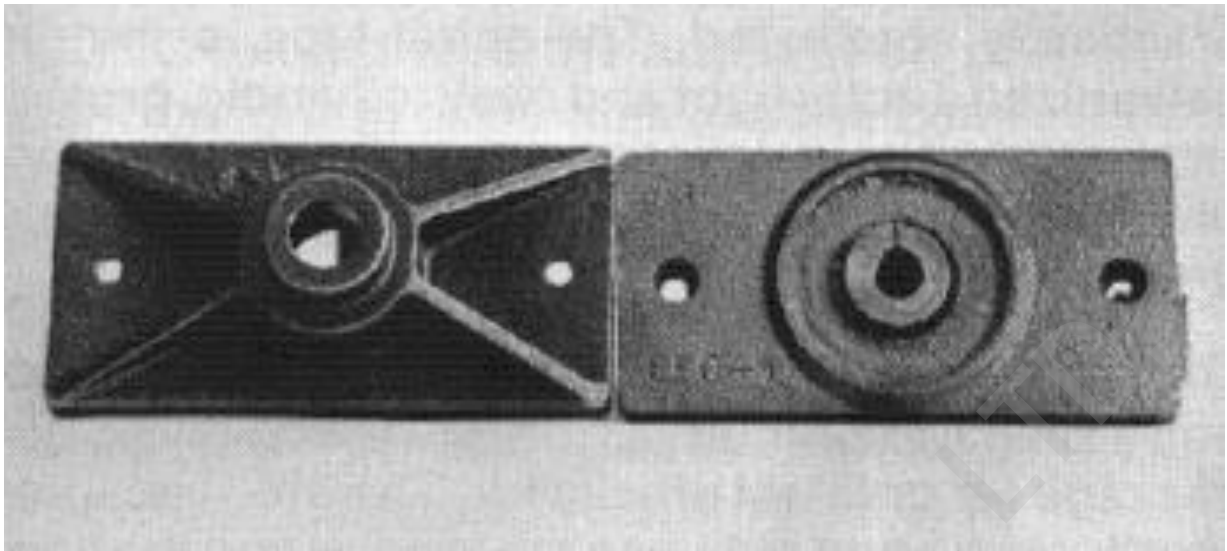
1. Anchorage Plate

There are 2 types of anchorages for this system

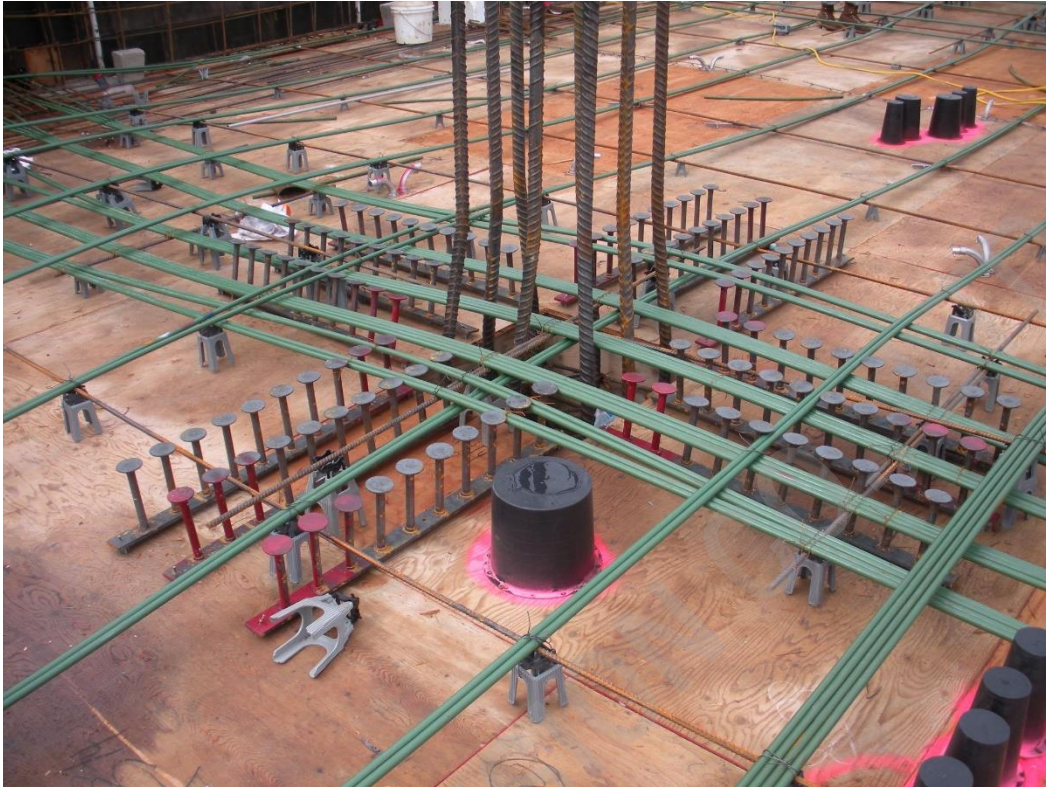
Tendon layout of unbonded post-tensioned slab

Normally, we use band-distributed layout in this system, one direction tendon located near column and one direction tendon were distributed.

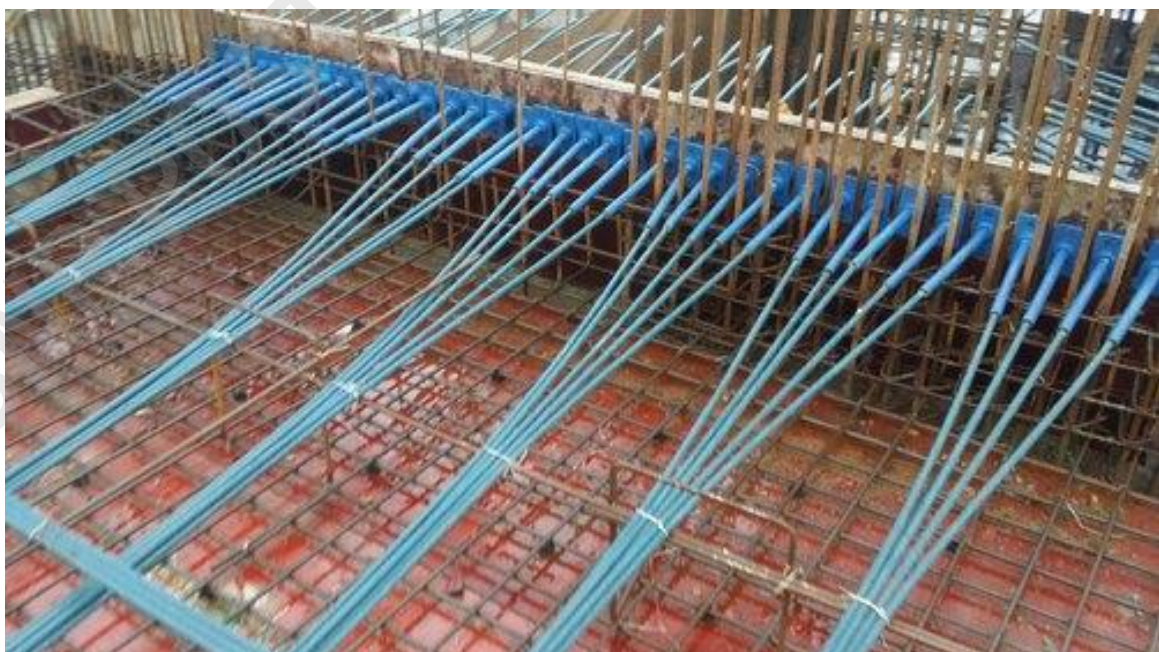
At edge of slab we will find number of anchorages equal to number of tendon. Tendon in slab were collected to bundle strip to easy to make their height vary in parabolic curve. In general tendon will be collected not more than 5 tendons in one strip.

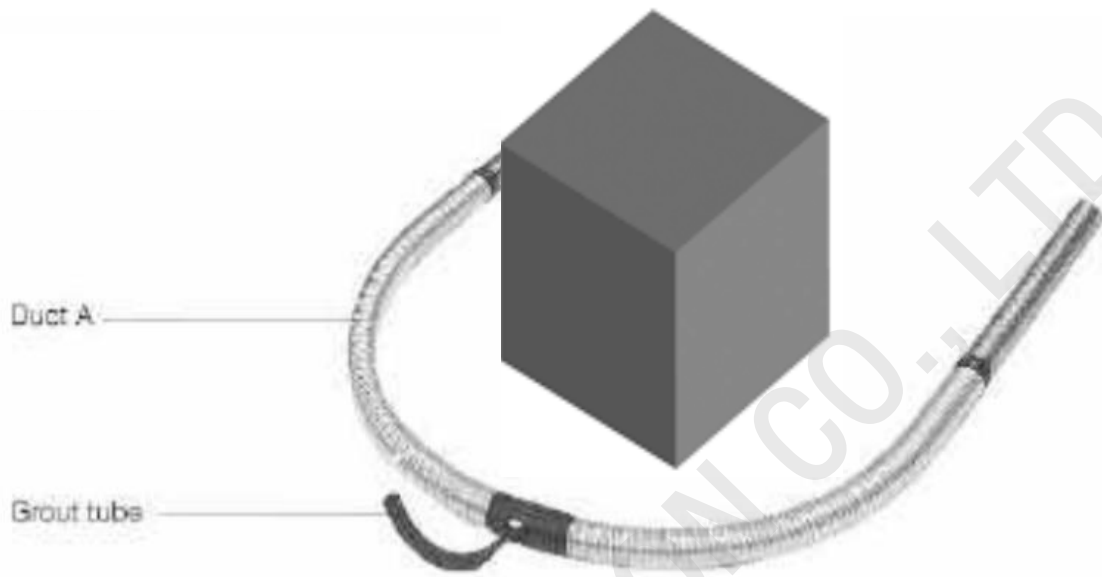
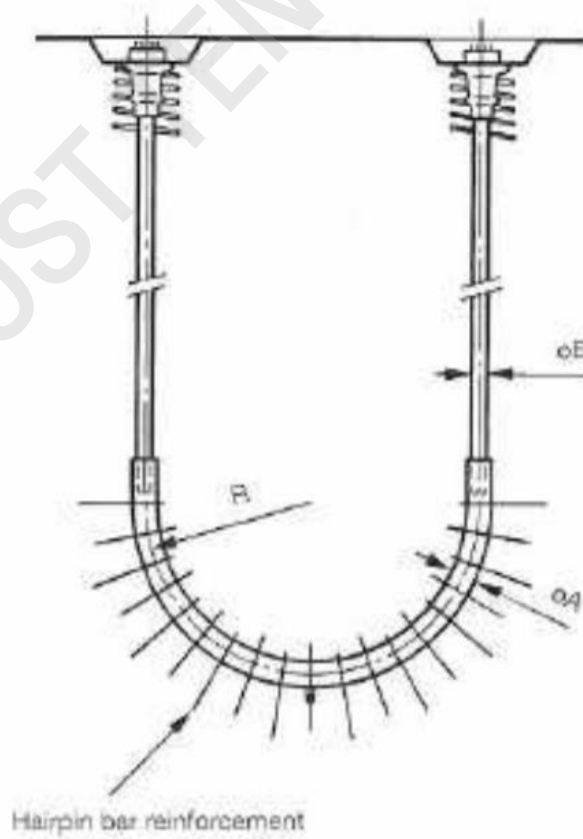
Some cases we found tendon was arrange in horizontal curve around column for reducing number of anchorages.

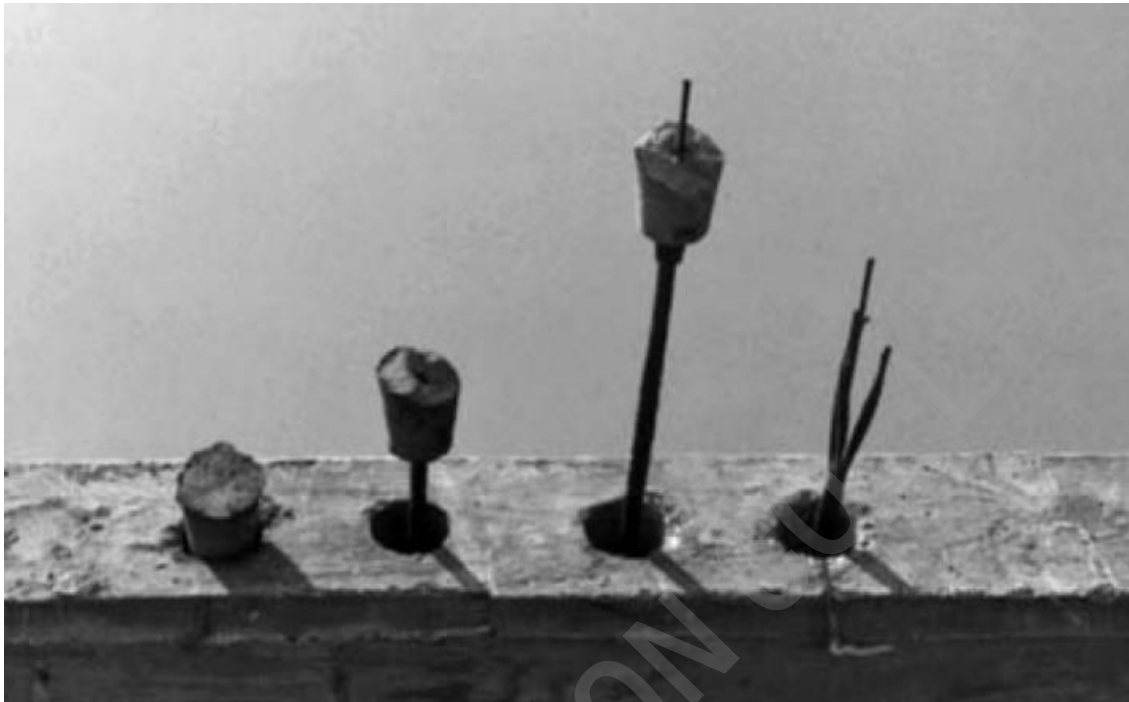
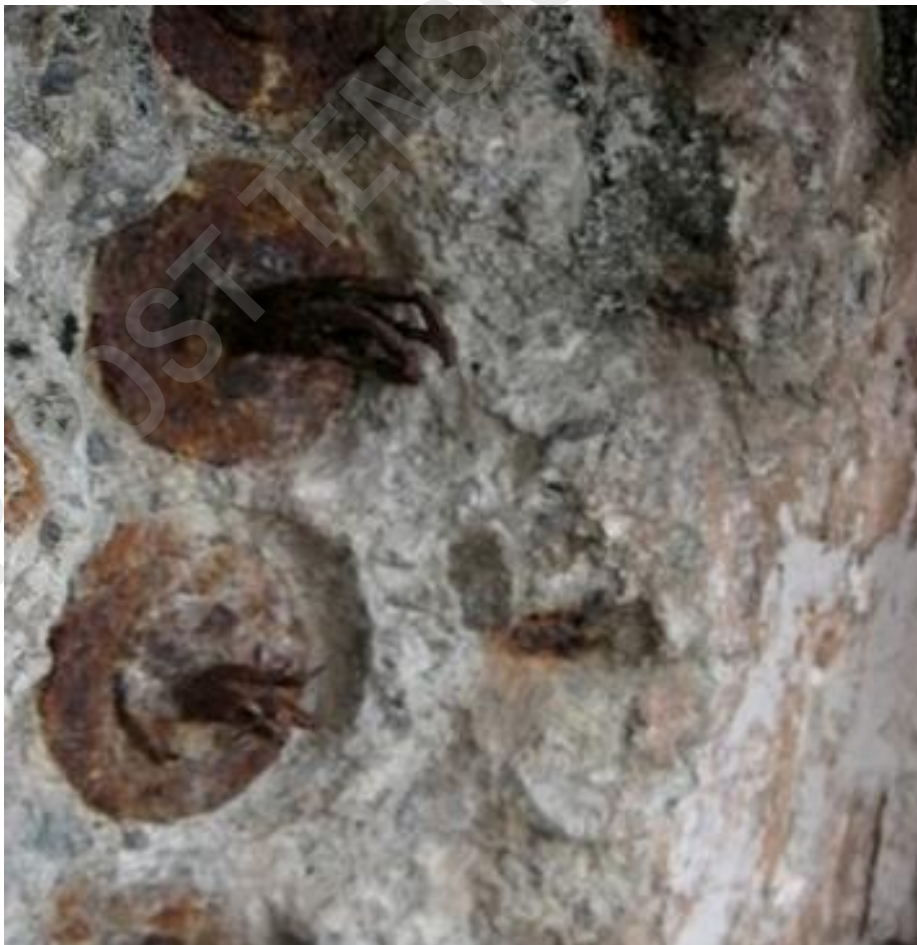
For old building in unbonded system, deteriorating anchorage and wedges can not lock strand. That is cause of strand can fly out from slab.

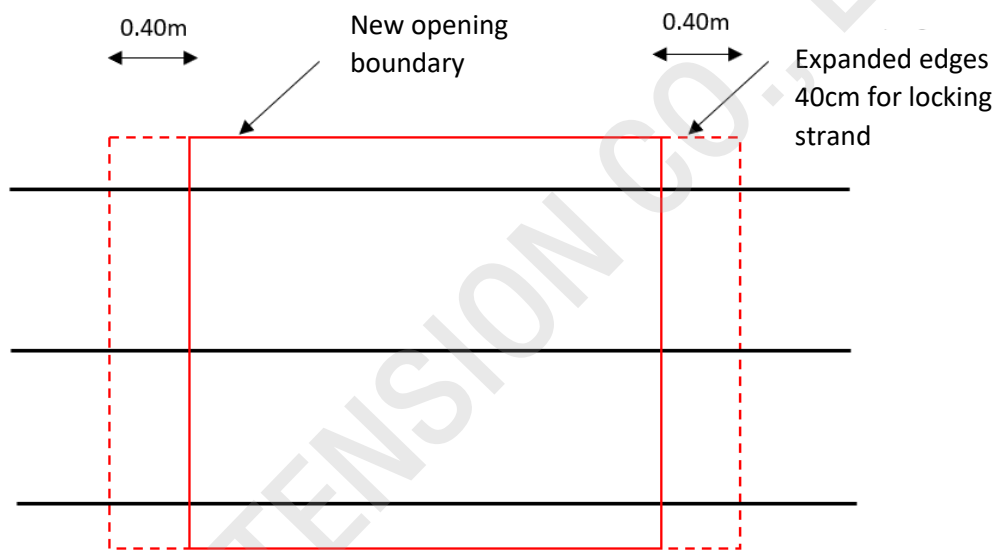
1. Marking area that require to make opening and marking tendon line from construction drawing or scan results. Marking expanded side for locking strand by new anchorages around 40cm.

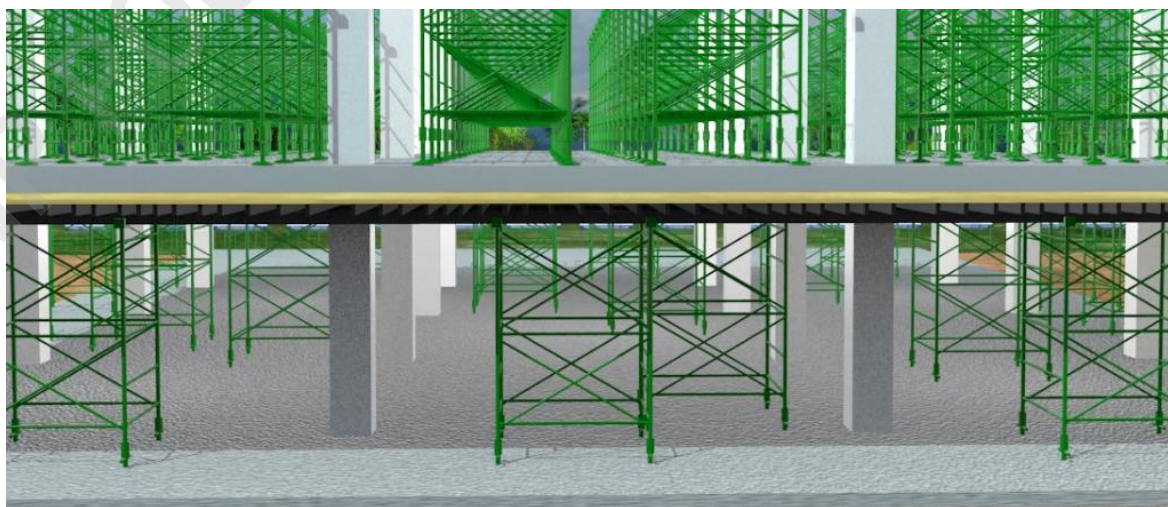
2. Provide scaffolding along cutting strands line because when strand was cut there are no force in strand.

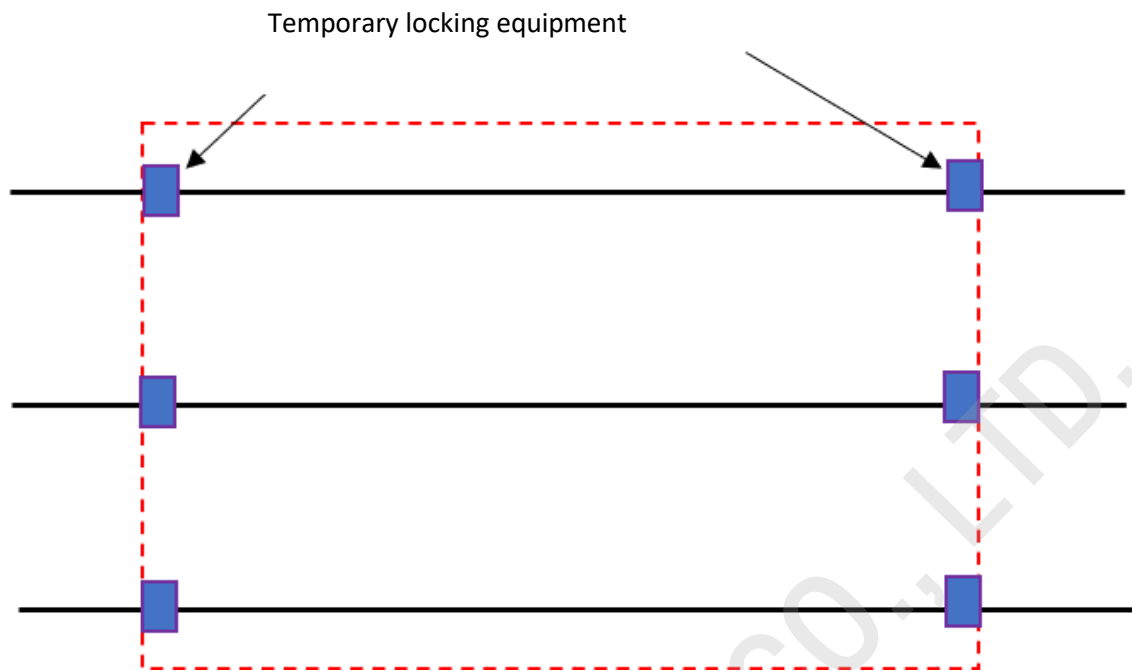
3. Extract concrete in marking area by remain strands. Install temporary locking equipment before cut strand.

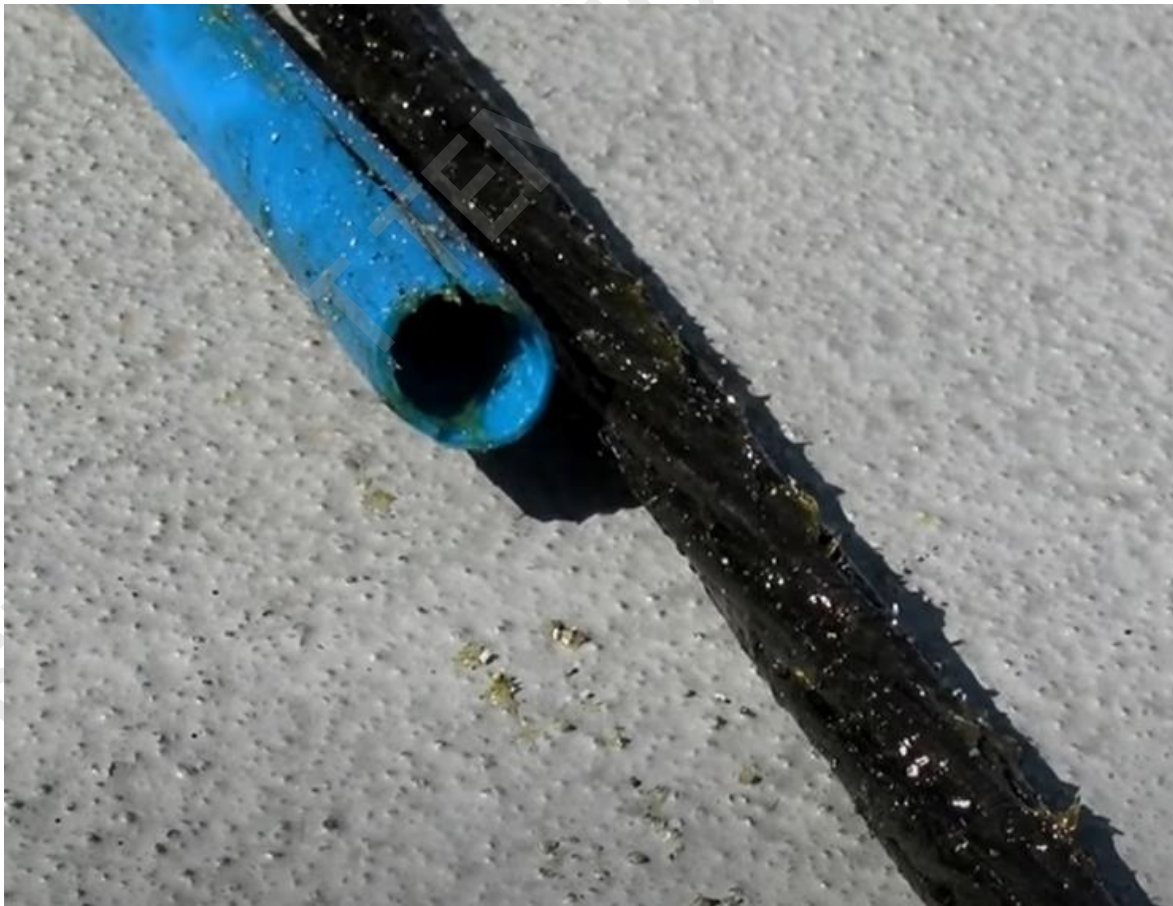
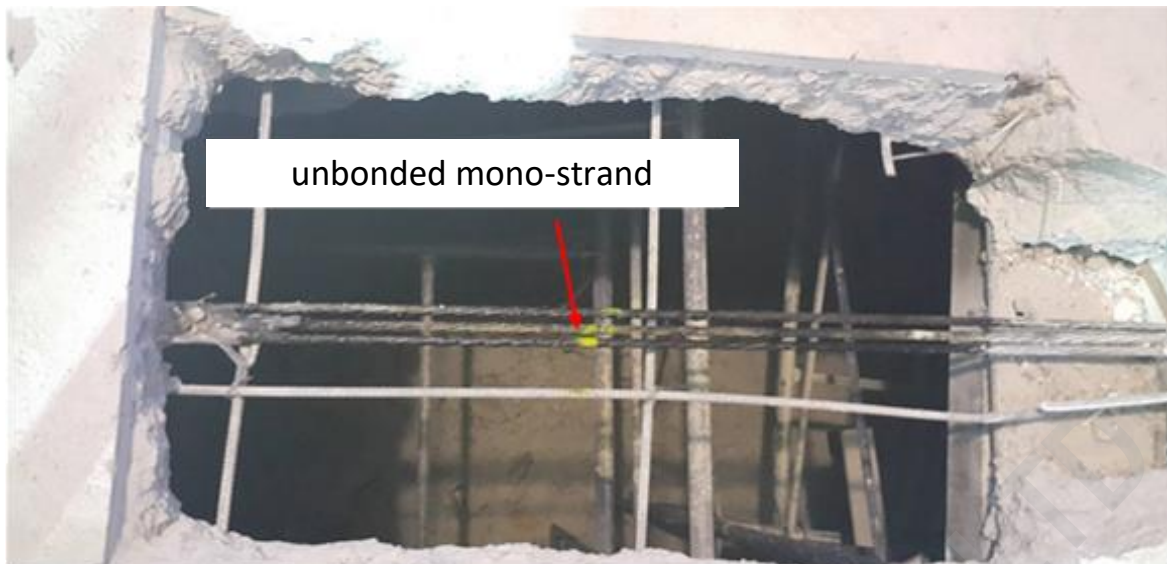
- Clean grease from strand

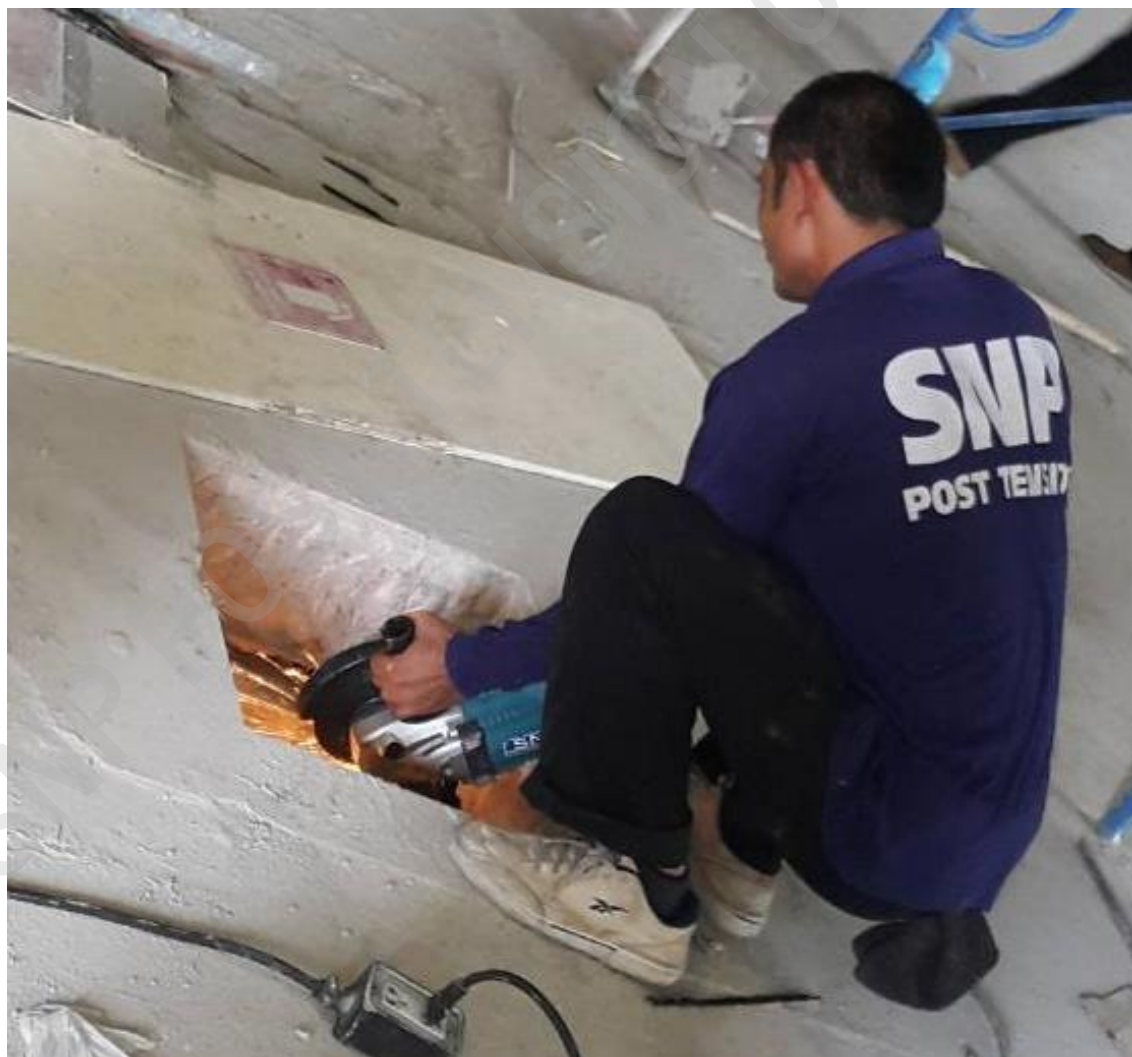
4. Cut strand after install temporary locking equipment and then release force in strand and move temporary locking out.

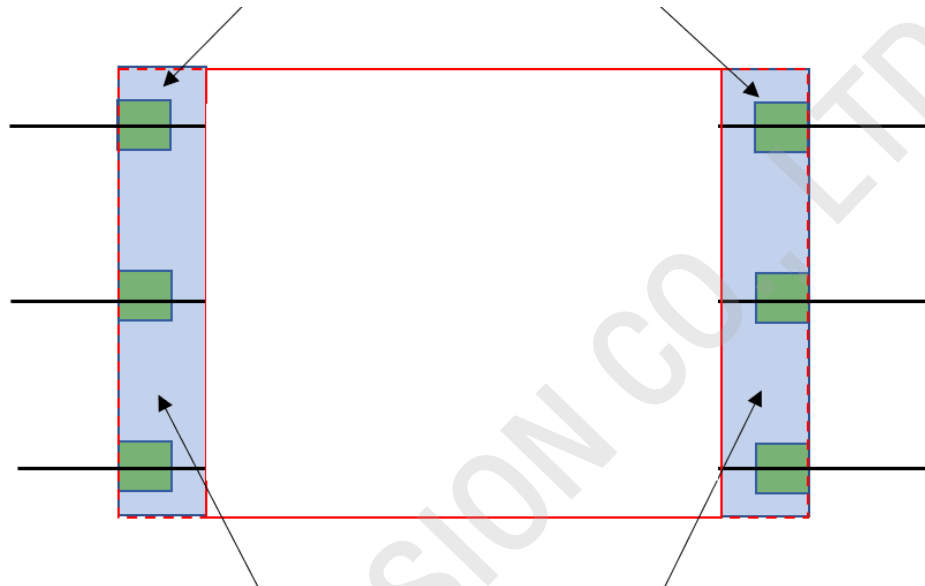
Install permanent locking equipment

5. If strands are not in good condition, we can remove and replace by new one. Install anchorage for permanent locking stand. Stressing strand until reach calculated elongation.
